BARBOURVILLE LEVEE PICTURES

April 6, 1977

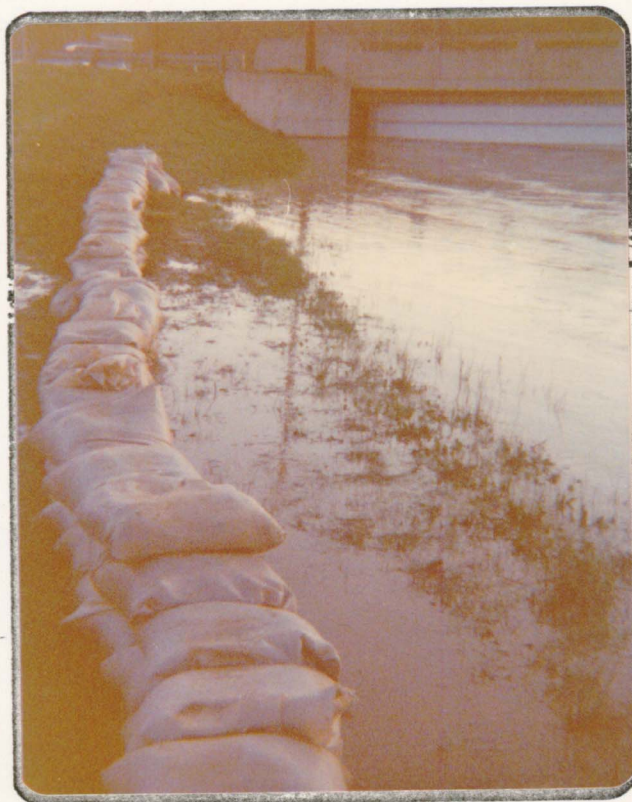
Photo #1

The first picture of the series was taken south (downstream) of the Kentucky 11 Bridge looking north. This picture was made at about 6:30 A.M. after the river had fallen approximately two (2") inches. The depth of the water at this location was measured at four (4") inches (Total 6" \pm). Records of the pictures were made on a tape recording.

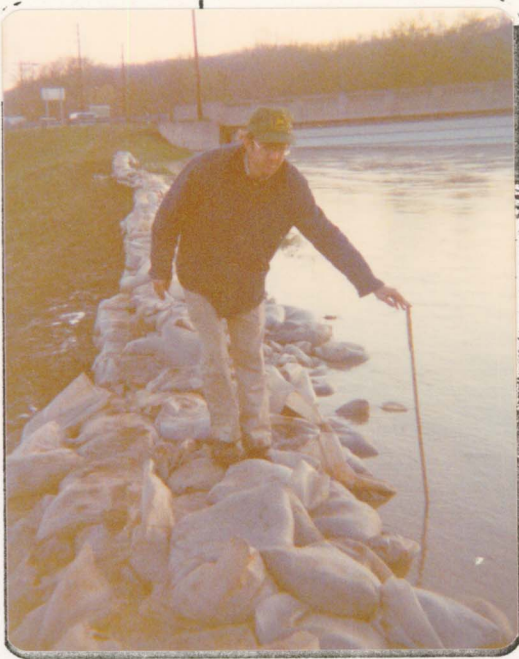
Photo #2

This photo was taken approximately 100 yards south (downstream) of the previous photograph. The water measured seven inches (9± inches total) at this location. Randy Bacon is shown in this photo.

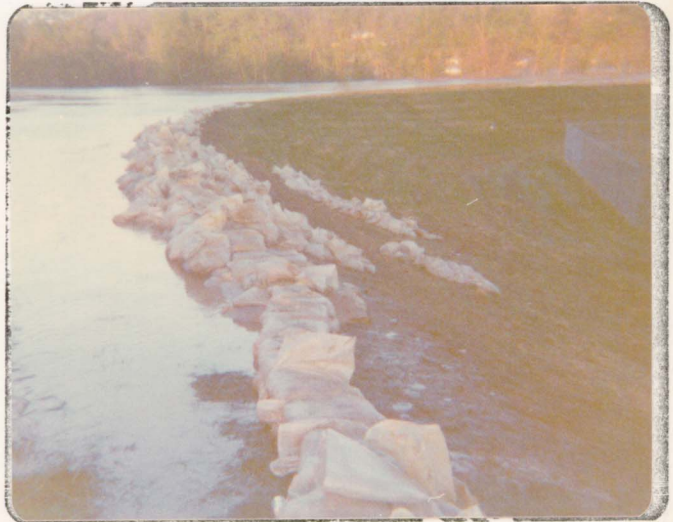
Photo #3

This photo shows the overall view of the lowest area of the levee dubbed "Sam's Dam" from the direction and efforts Sam Davies put forth in its construction and maintenance throughout the night. The water was measured at 12 inches; however, later reports indicate the depth was greater. It is probable that the writer's measurement was to another level of sandbags.

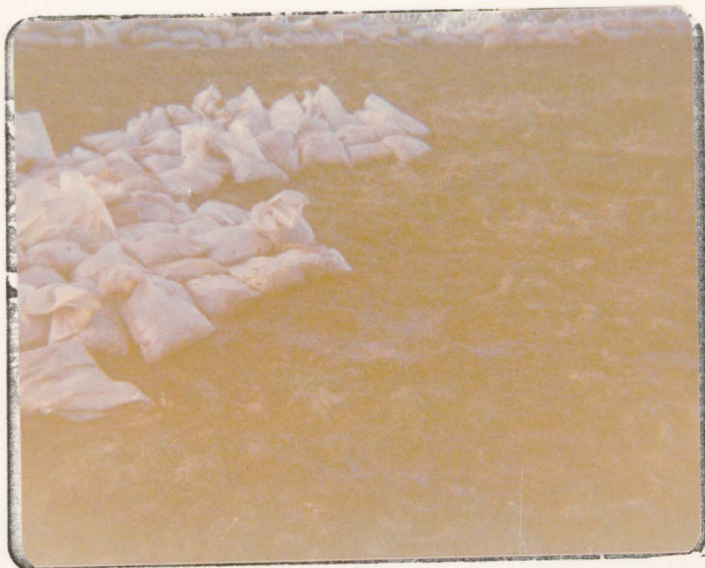
Photo #4

An attempt to show detail of
blanketed area where truck
tracks had begun "piping".
Detail poor due to lack of
proper light. General area
is shown in previous photo.

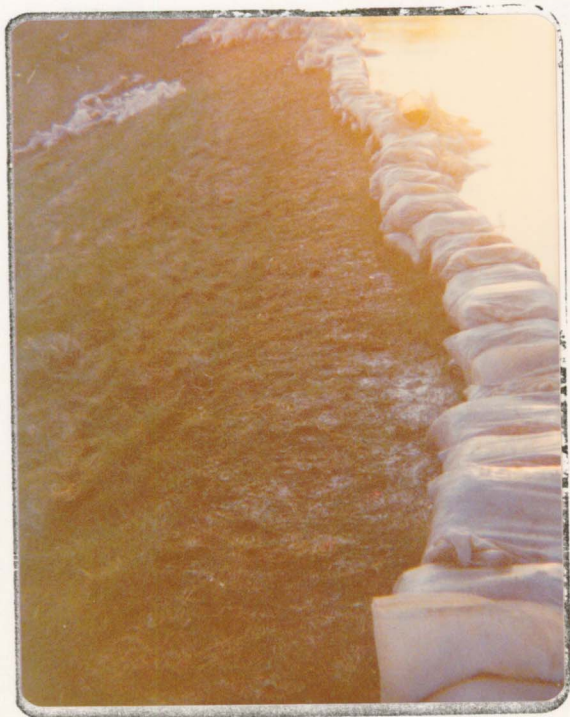
Photo #5

"Sam's Dam" south abutment

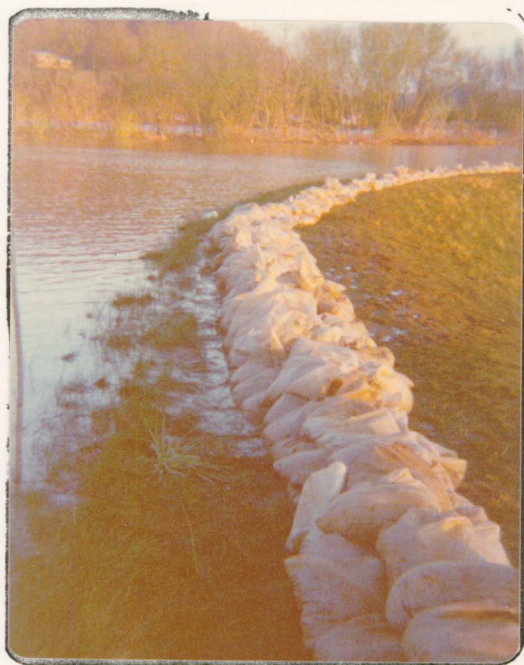
Photo #6

Same area as Photo #6. Mr.
Bacon measured four (4") inches
(depth totaled 6+ inches).

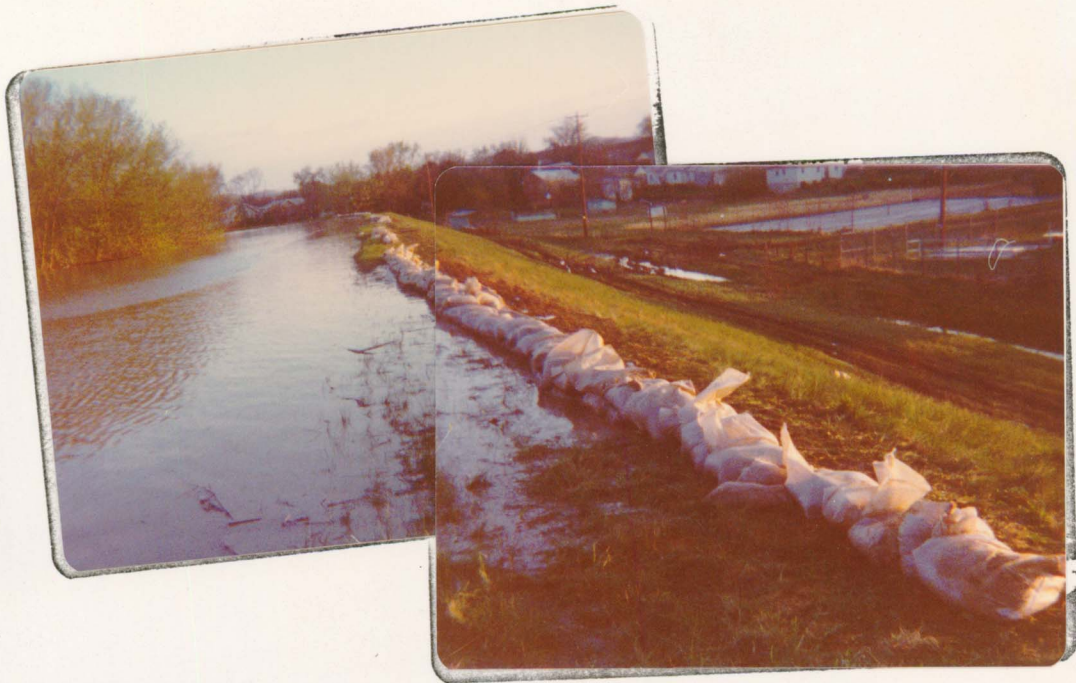
Photo #8

A composite showing the area behind the City Recreation Park. The water height measured four (4") inches, by now the water had probably receded three (3") inches or more. Note the tracks at the base of the levee and the surface water near the toe of the levee.

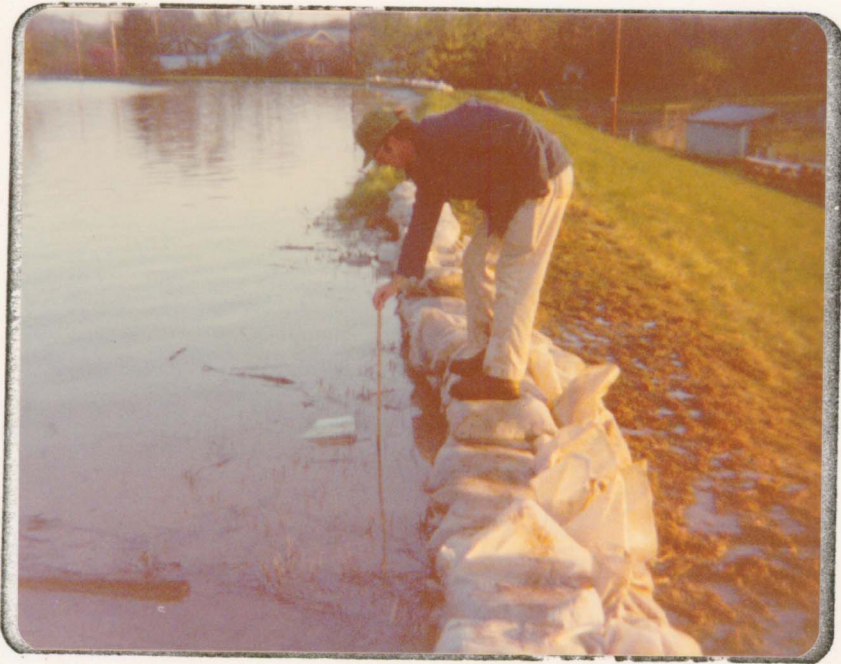
Photo #9

Mr. Bacon measures five (5") inches at placement behind the City Recreation Park. Note player's bench in the background for location. Relationship to previous view indicates location. Note also that the area over Bacon's shoulder is not sandbagged.

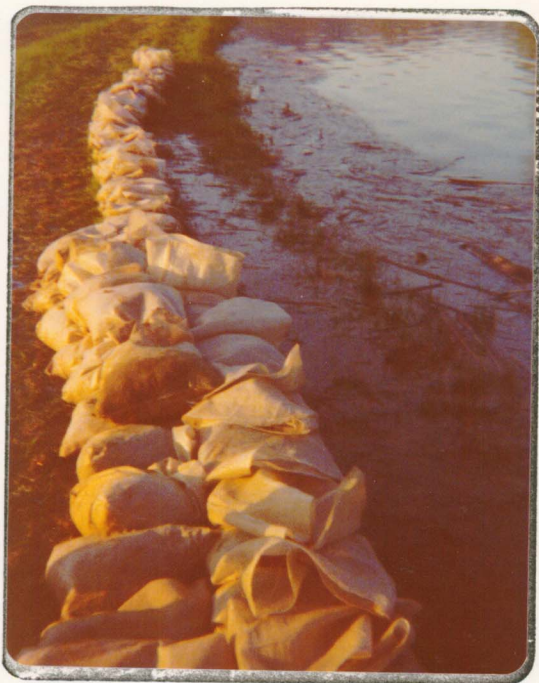
Photo #10

The bagged area on the south side of the Pitzer Street Gate. Light getting better - note height of grass and water in grass. Also, remember the water has dropped some three (3") inches.

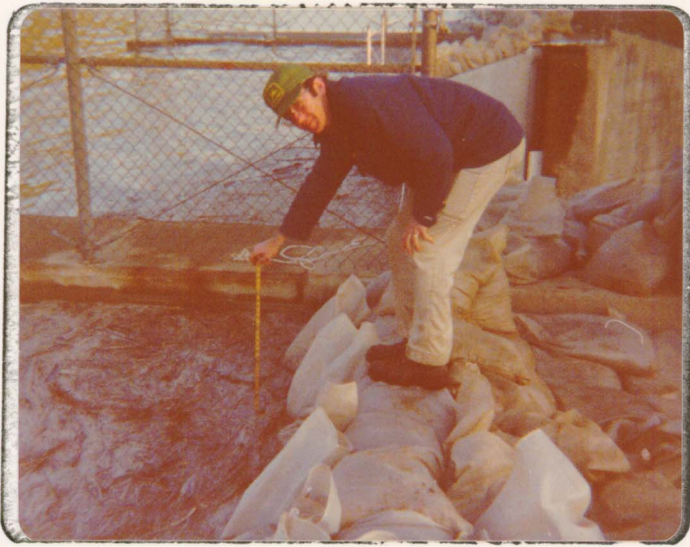
Photo #12

South Abutment of Pitzer Street Gate. Measurement of one foot (12 inches) after about three (3") inch drop. Note water line on abutment (\pm 1" below top).

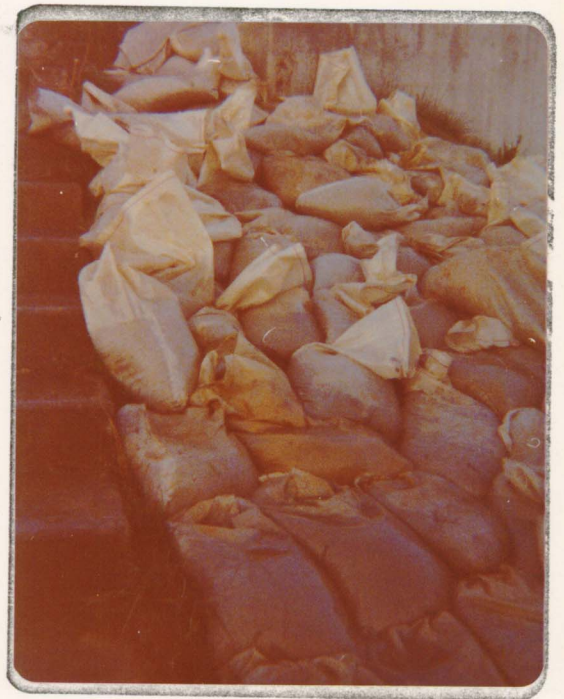
Photo #13

Blanket area at south wing to protect against "piping". Conley Congleton manned this area and did an excellent job of protecting the city at this critical location.

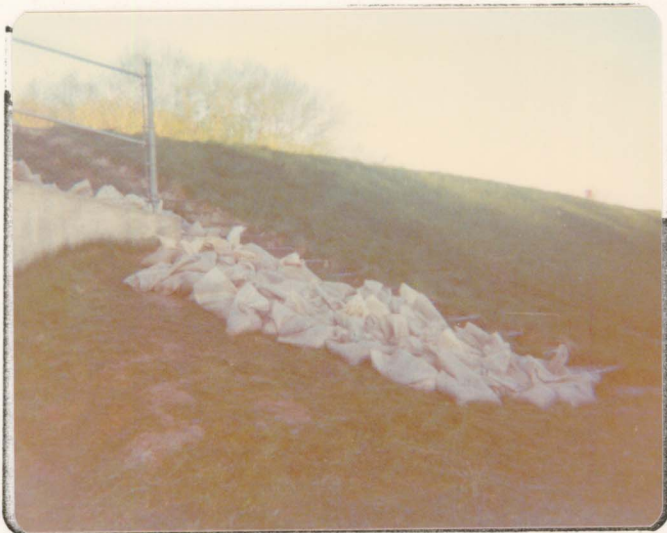
Photo #14

Overlay of wing area on
north wing.

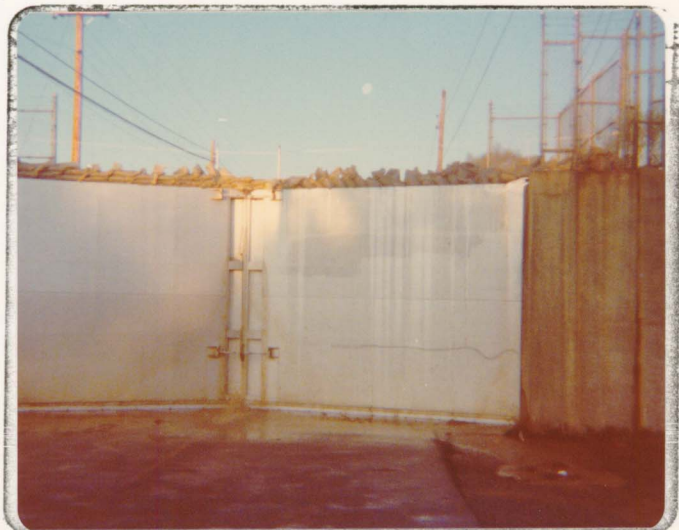
Photo #15

Straight-on view of the
Pitzer Street Gate. Note
moon and streaks down gate.
The water flowed through the
bags and came down the gates
in sheets, nearly uniformly
across the gates.

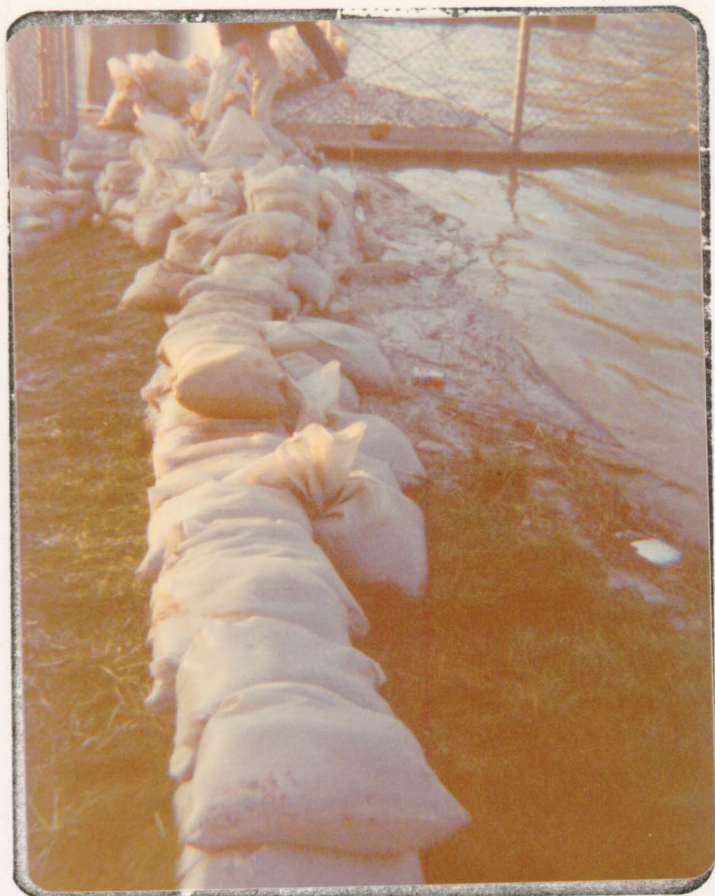
Photo #16

This photo shows the north side of the gate looking downstream and toward the river. Water measured ten and one-half (10-1/2") inches. Note that water overtopped the abutment (believed by the City to be settling). Differential heights of abutments are visible in this picture and picture 12. Seven o'clock A.M. when we leave this area.

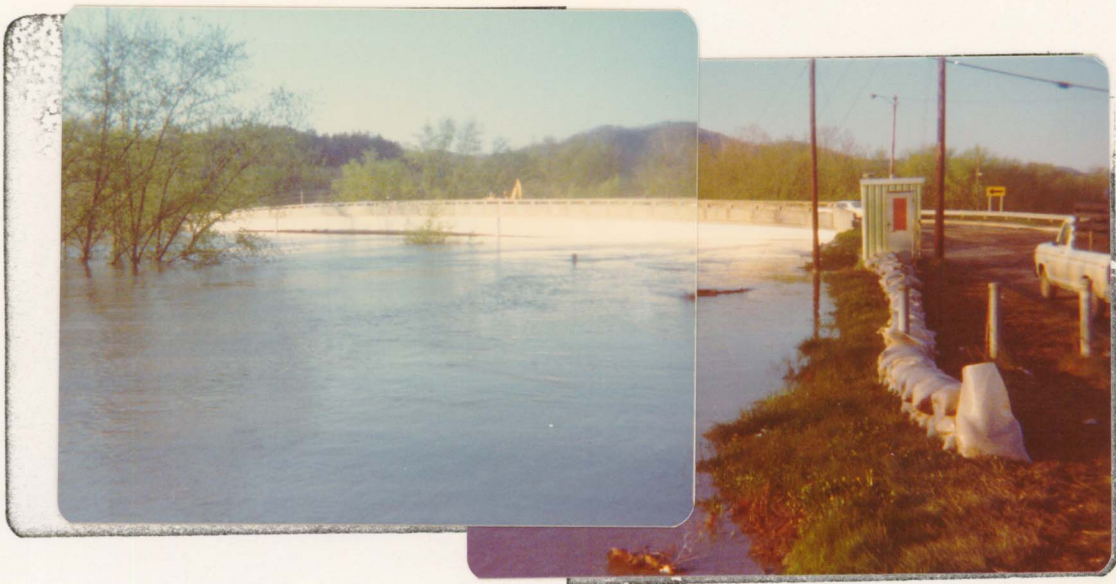
Photo #17

Back to the beginning point - View of Kentucky Highway 11 Bridge from the north looking downstream. Staff gauge overtopped but mounting pole visible. River dropped three (3") inches officially. Note the remaining opening under the bridge.

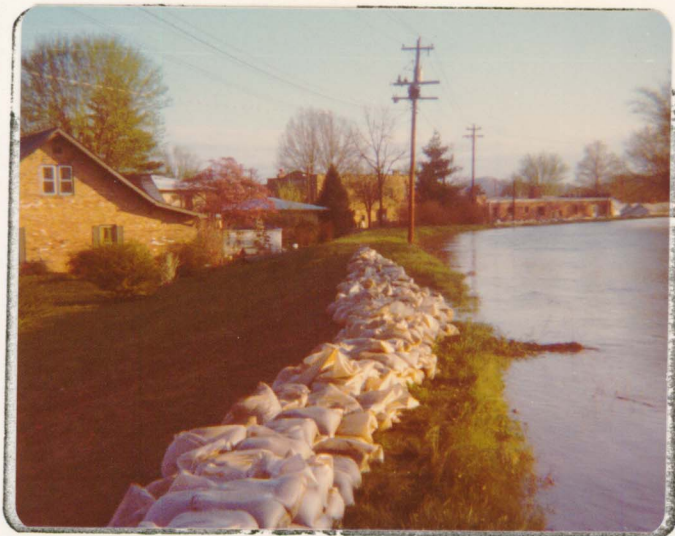
Photo #18

Looking north (upstream) from about the same vantage point as Photo #17. Measured four (4") inches in low area after official drop of three (3") inches.

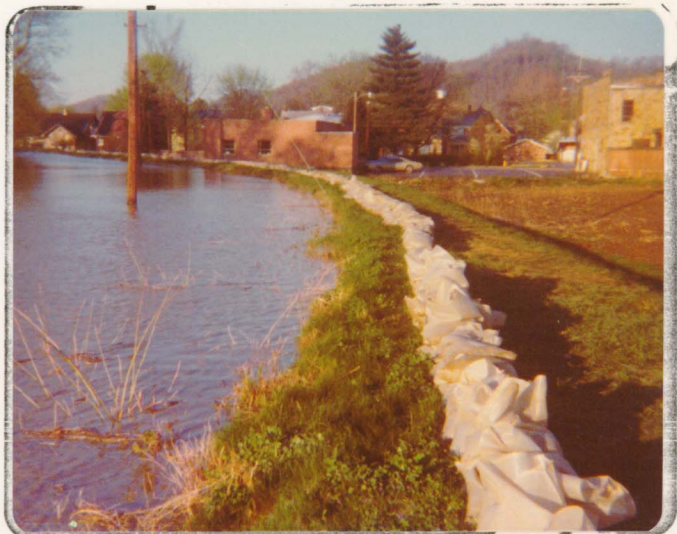
Photo #19

Looking south (downstream) from near old fire hall. It appears these sand bags were of no benefit, but look at drop on pole and remember grass height.
